A flaw in classic approach to flooding: the floods of 2021

June 22nd, 2022

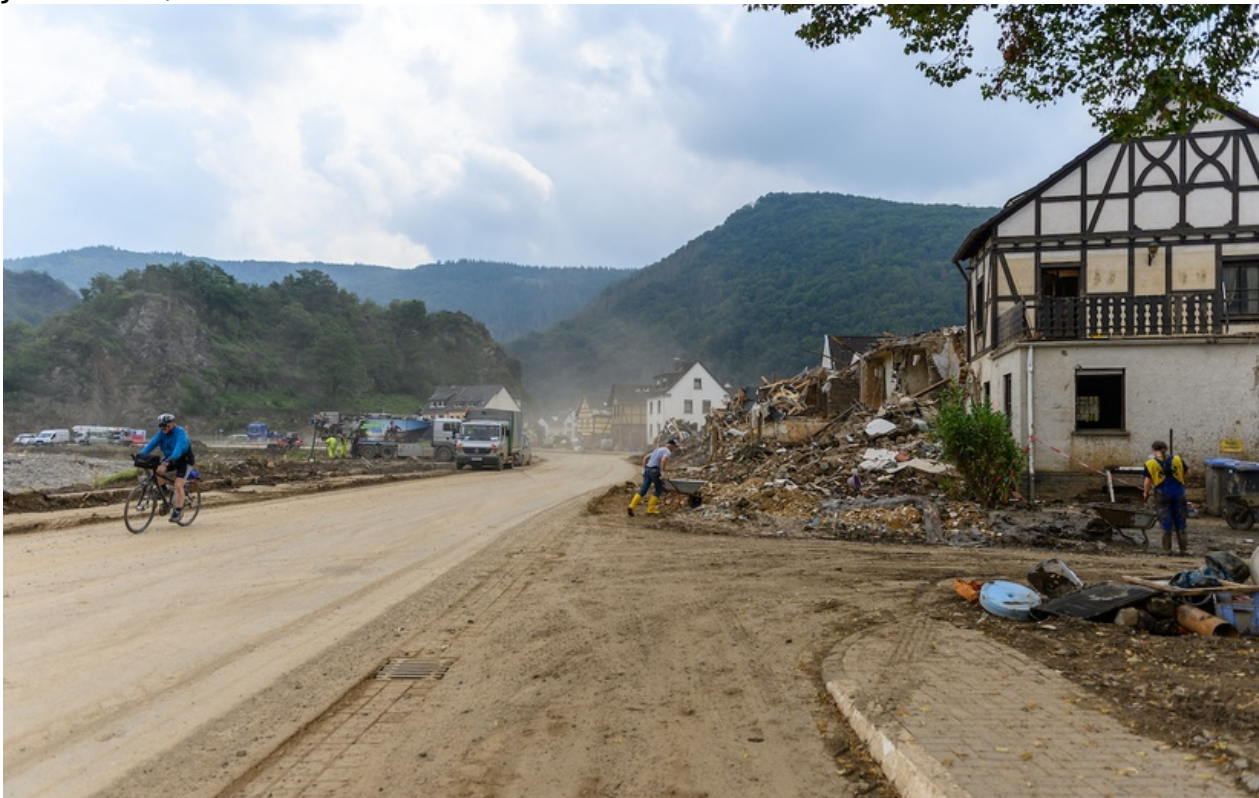
Photo: Damage of the 2021 flood in Germany (source: Max Gerlach, www.flickr.com)
